LANDSLIDES AND RELATED FEATURES

OF THE WINDROCK, TENN. QUADRANGLE

1982

U.S. Geological Survey
OPEN FILE MAP 82-653 (A-14)

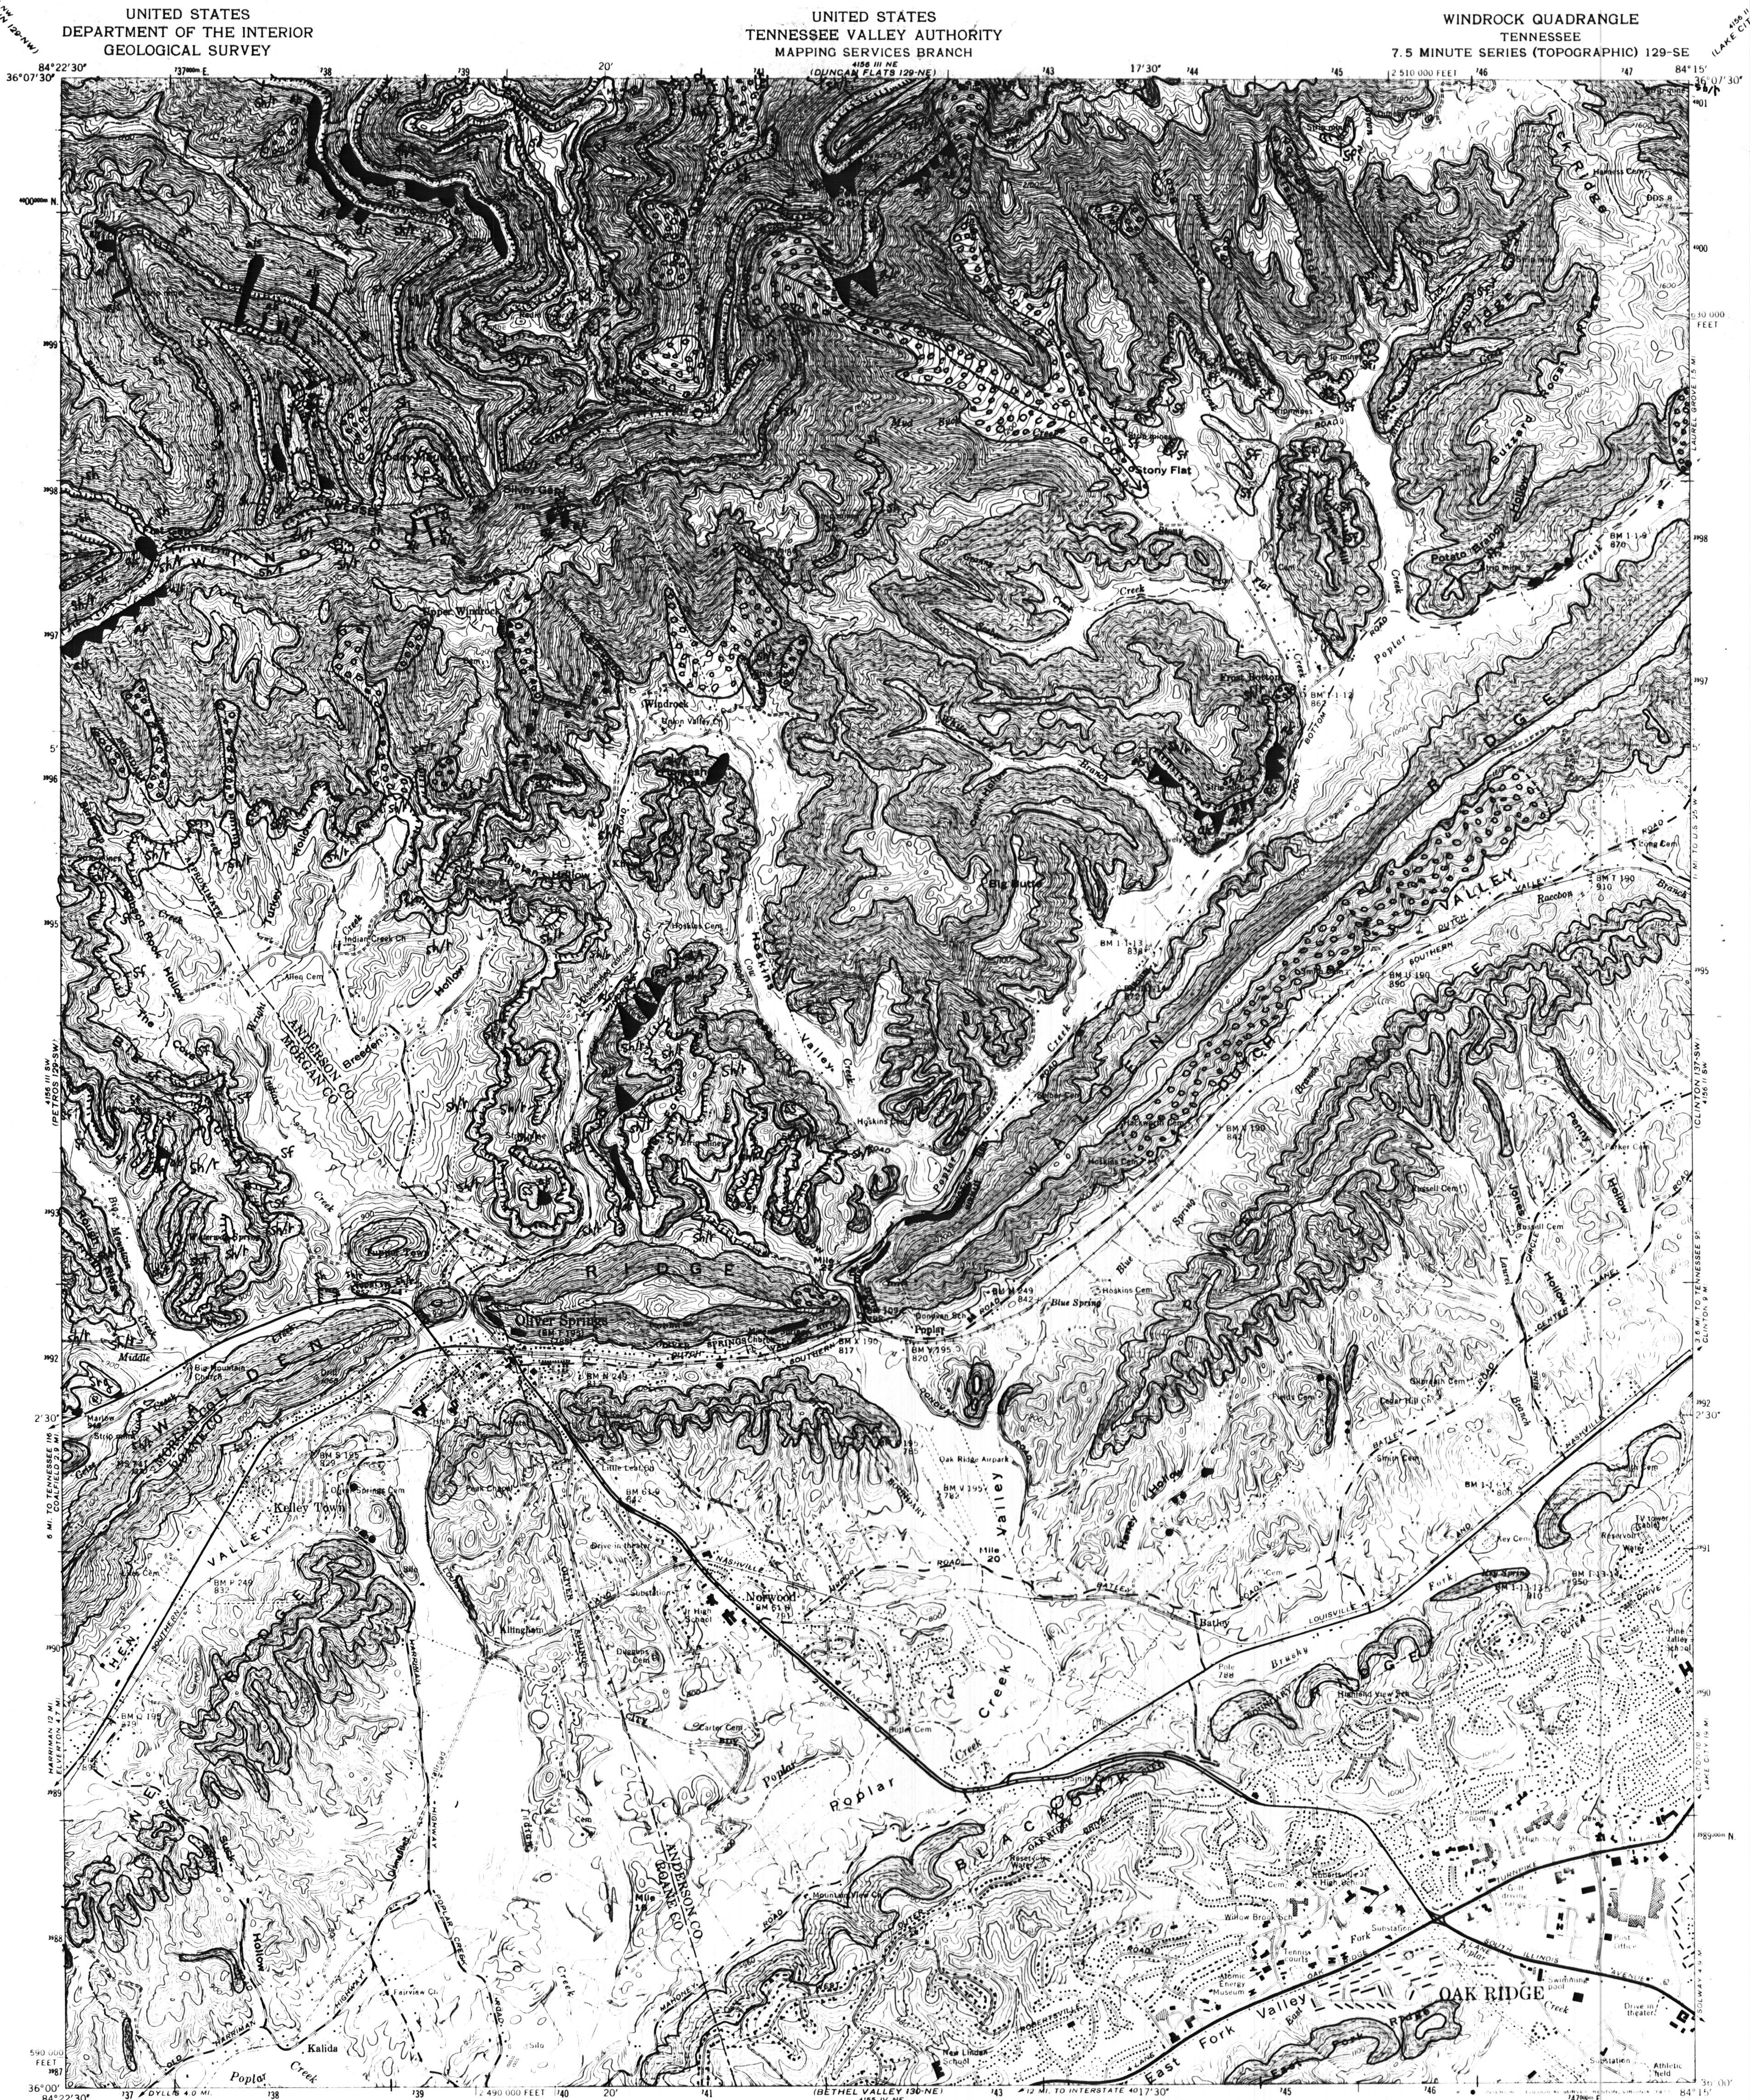
Landslides and related features interpreted
from aerial photographs:

Photointerpretation and field check 1979-1980, 1982
This report is preliminary and has not
been reviewed for conformity with U.S.
Geological Survey editorial standards.

**ACTIVE OR RECENTLY ACTIVE LANDSLIDE**
Complex landslide composed of earthflow, debris slide, earth and rock slump. Identified from historical records, and from scars, debris and other field evidence. Ground extremely unstable; sliding accelerated by excavation, loading and changes in drainage conditions. May include areas with several active slides too small to be shown separately. Questioned where doubtful.

**OLD LANDSLIDE**
Area of extensive hummocky ground caused by earthflow and earth and rock slump. Lacks clear evidence of active sliding. Relatively stable in natural, undisturbed state, generally not affected by small structures properly sited in areas away from the edge of the toe; can be reactivated by extensive, rapid excavation, loading, and changes in ground water and surface water conditions. Area of old landslide probably includes recent ones not identified from field evidence or otherwise documented. Upslope boundary of landslide generally defined by modified scarp, but downslope (toe) may be gradational and not well defined. Questioned where doubtful.

**COLLUVIAL SLOPE**
Valley wall along major streams with slope as steep as 40° (85%); stony, clayey silt soil up to 50 ft. (15 m) thick; commonly buttressed by a terrace or bench at the toe of the slope; very susceptible to sliding by cutting of toe area, removal of terrace or bench, and overloading; slide commonly activated without apparent cause.

**AREAS SUSCEPTIBLE TO DEBRIS FLOWS AND DEBRIS AVALANCHES**
Primarily shallow, narrow ravines and chutes with accumulation of stony colluvium generally 10 ft. (3 m) or less in thickness; susceptible to rapid movement during intense rainfall. Most ravines and chutes designated show evidence of former debris flows and avalanches.

**AREAS SUSCEPTIBLE TO ROCKFALL**
Steep, locally vertical, natural and man-made slopes and cliffs, 15 ft. (4.5 m) or more high; formed dominantly of sandstone, limestone, sandy shale, mudstone and claystone. Interbedded mudstone, claystone and shale weather rapidly leaving sandstone and limestone rock faces unsupported.

**SOIL AND ROCK SUSCEPTIBLE TO LANDSLIDING**
Soil and rock similar to that involved in landslides elsewhere in map area; primarily areas underlain by claystone, mudstone and shale associated with other rock types. Rock weathers rapidly on exposure forming clayey soil highly susceptible to sliding. Includes coves (U-shaped, shallow valleys) containing thick layers of clayey soil that are very susceptible to sliding where excavation breaks continuity of slope and where overloaded by artificial fill.

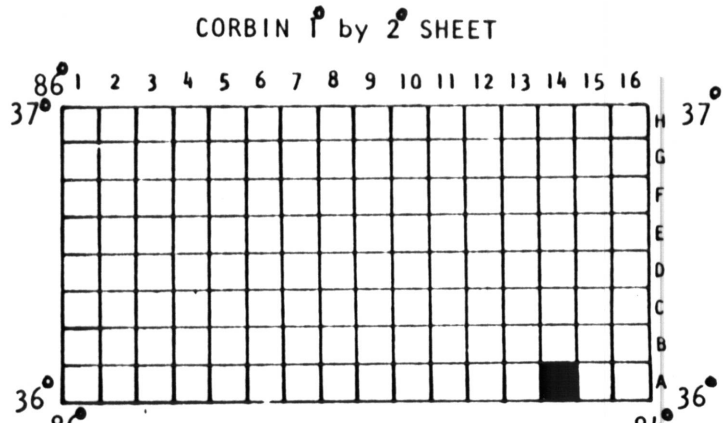
The first five digits of the open file number designate the specific 1:250,000 scale map sheet of which this quadrangle is a part. The last two digits designate the position of the quadrangle in a subdivision of the 1:250,000 scale map based on rows and tiers shown in the diagram to the right. The location of this quadrangle is shown by the black square.
